Dam Safety Inspection Report

DAM: LAKE CHARMAINE DAM

OWNER: CITY OF IVANHOE

CURRENT INSPECTION DATE: 6/14/2017

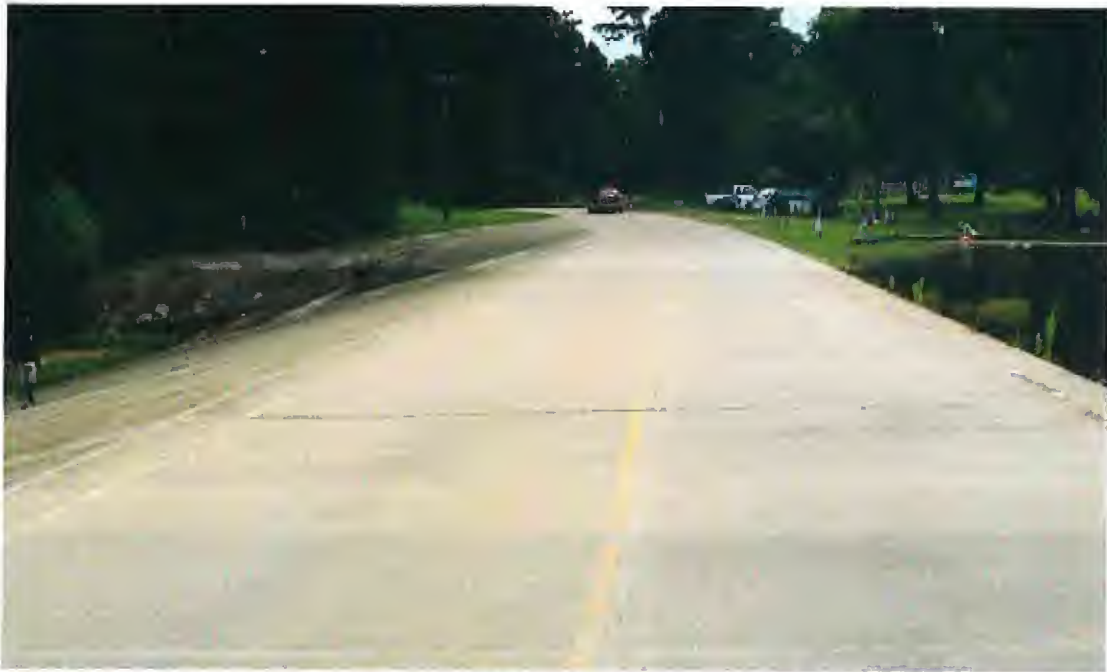
- The dam is 1200 feet long with a crest width (concrete roadway) of approximately 24-ft. The crest was relatively level with no dips or low spots and was found to be in good condition (See Photos 1 and 2).
- Elastic sealant that was noted as missing in some joints from the previous inspection appeared to have been applied everywhere as needed.
- The area of the crest at one of the joints where the 16 cubic yard void was previously detected and was noted to have been filled with flowable fill and

Photo #1 – Crest of dam (roadway) approximately 24-ft wide looking south.

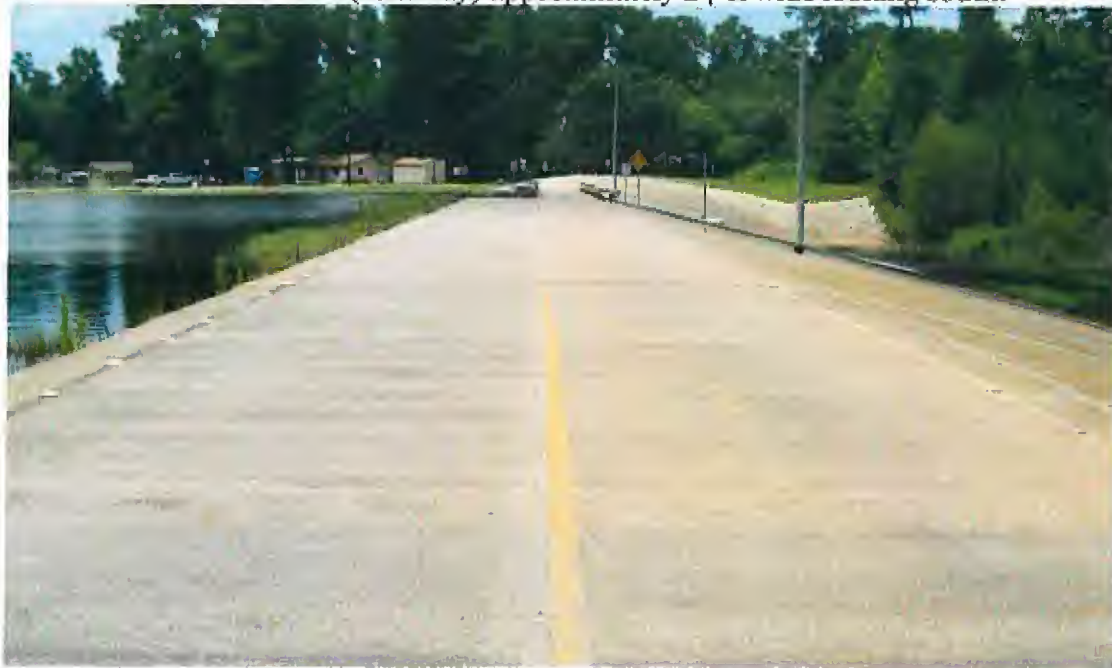
Photo #2 – Crest of dam near the mid-point of the dam looking north. Crest was level with no dips or low spots.

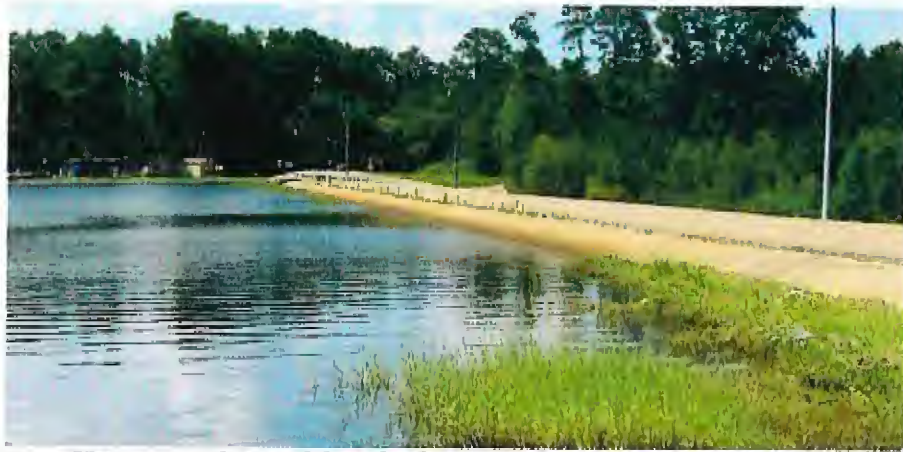
Photo #3 – Upstream slope of dam looking northeast.

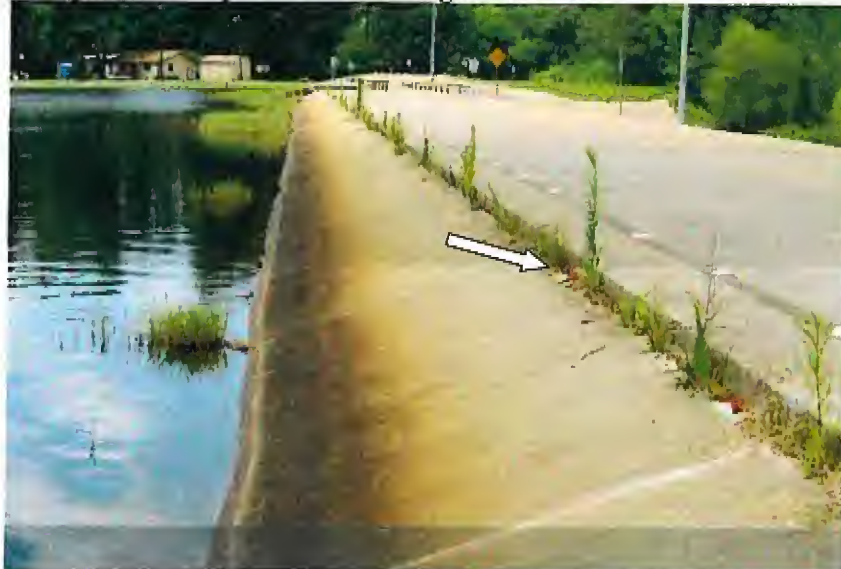
- The upstream slope was capped in concrete slabs with a consistent surface estimated at approximately 3 horizontal to 1 vertical (3H:1V) and was found in good overall condition (See Photos 3-7).
- The previous inspection had noted an open joint between the upstream slope and the crest. That joint was filled with sealant during this inspection. However, small grass was also growing through some of the joint areas.

Photo #4 – Upstream slope of dam looking north. Note some grass growing through the joint (arrow) at the crest and upstream slope.

- The following are recommendations for addressing the maintenance items noted during the inspection:
 - a) Clear grass growing through open joints and reseal as needed.

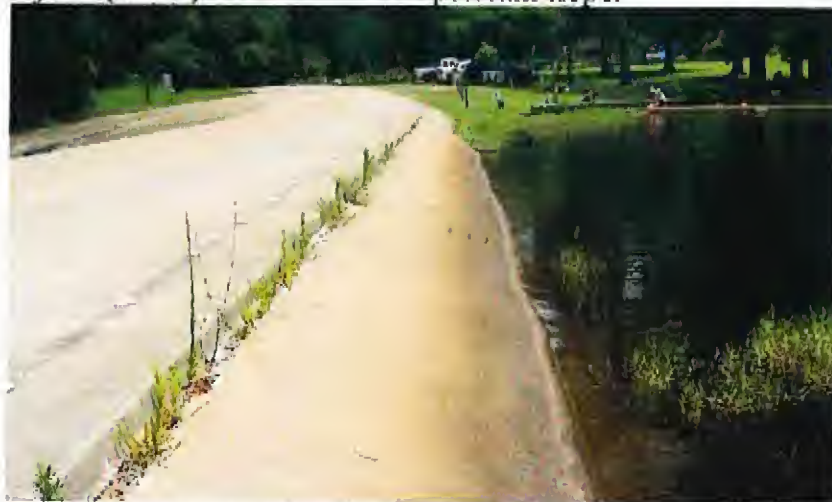
Photo #5 – Upstream slope of dam looking south.

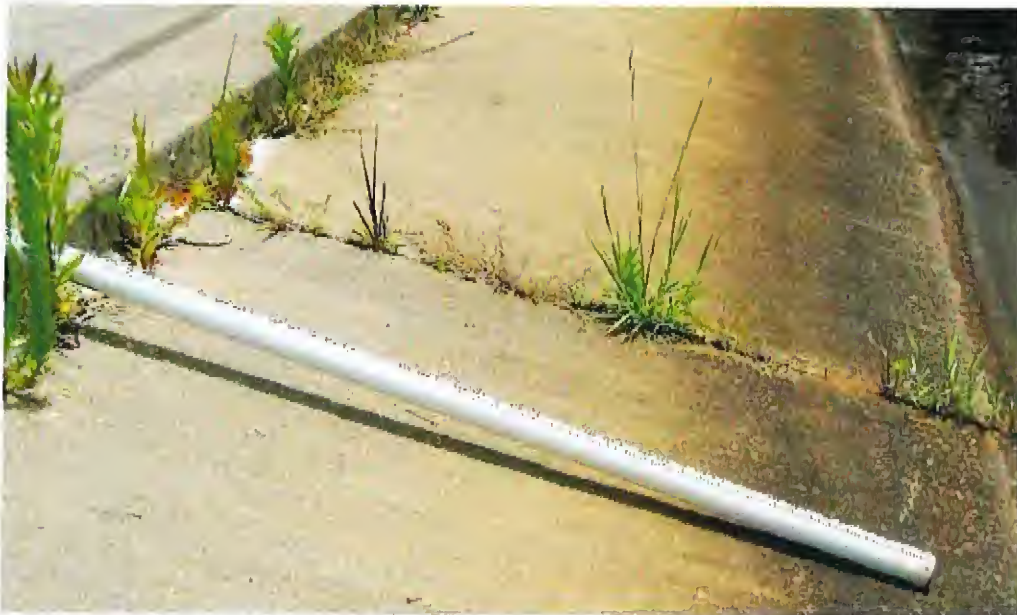
Photo #6 – Close up view of upstream slope of dam looking south. Note the grass growing through at the joints.

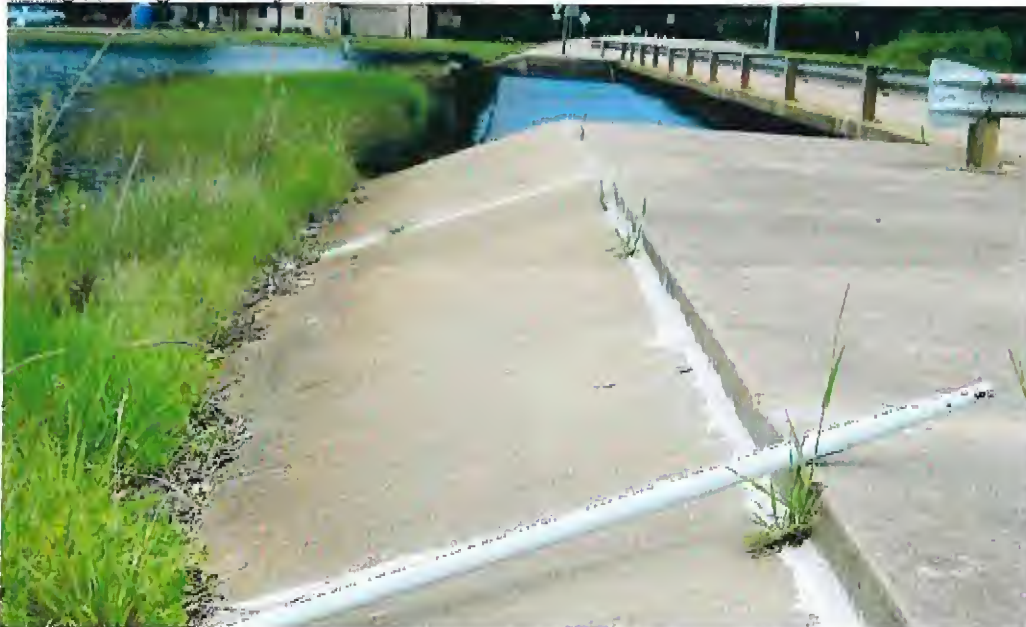
Photo #7 – Close up view of upstream slope of dam looking north. Note the joint between the crest and upstream slope has had sealant placed since the last inspection.

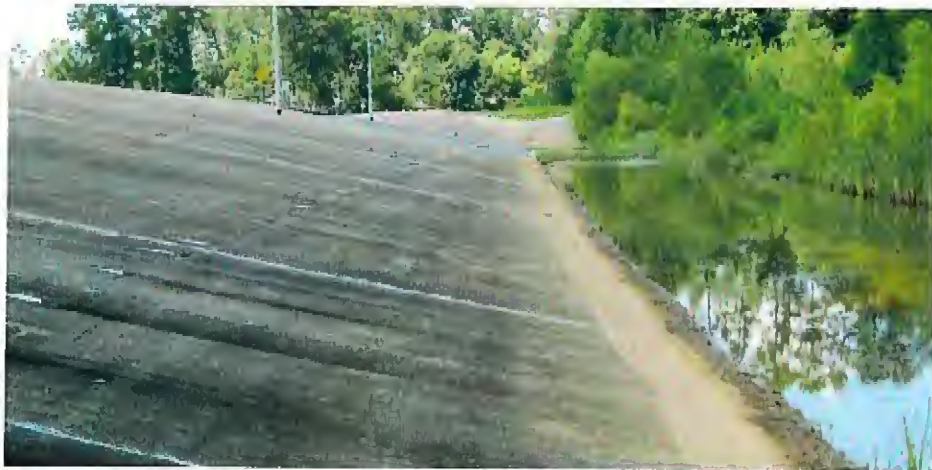
- The downstream slope was capped in concrete slabs with a consistent surface estimated at approximately 3 horizontal to 1 vertical (3H:1V) and was found in poor overall condition (See Photos 8-12).

Photo #8 – Downstream slope of the dam looking north. Note the consistent slope.

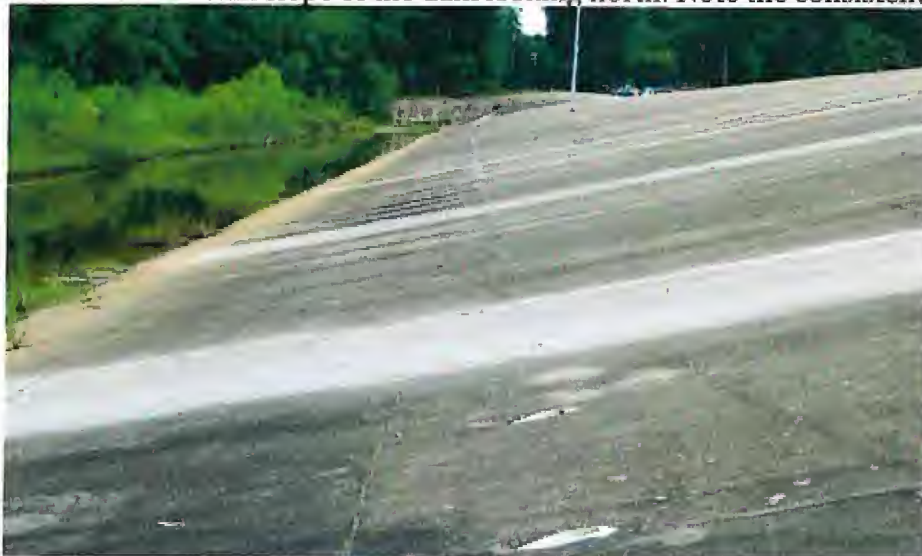
Photo #9 – Downstream slope of the dam looking south.

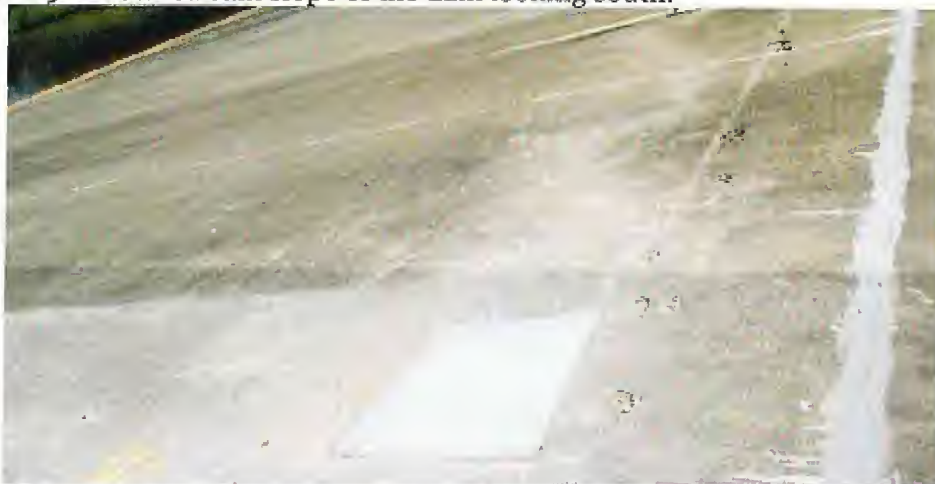
- Some cracking with evidence of seepage emanating from cracks was noted close to the right end of the downstream slope (near the stilling basin).
- Concrete patches, which were noted near the top of the slope closest to the spillway, identified where grout was pumped under the slabs to fill voids.

Photo #10 – View of dam's downstream slope. The square patch is one of the bore locations where grout was pumped into a void found under the slab.

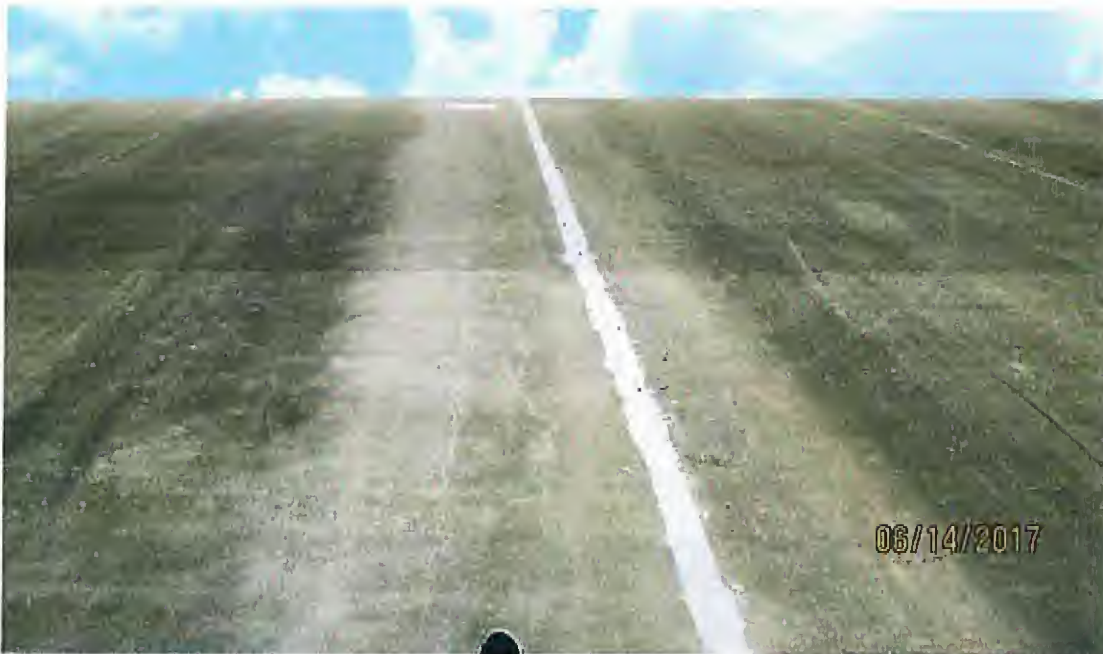
- Sealant (which appeared relatively recent) was noted at all joints that in past inspections showed several large gaps.
- Weep holes at the base of the slope appeared to be clear of debris and sediment. The previous inspection noted that many of these were clogged. However, it was unclear if they were effective as no evidence of drainage was observed and seepage appeared from nearby cracks.

Photo #11 – View of dam's downstream slope near mid-point of dam looking west. Note the sealant at the joint in effort to prevent seepage under the slab. Additionally, the weepholes were found to be cleared of debris.

- f) Monitor steel cable grates for damage, and repair if grates fail or become unserviceable due to damage from debris.
 - g) Monitor weep holes for evidence of drainage to determine if they are effective in relieving pressure from behind the concrete slabs.

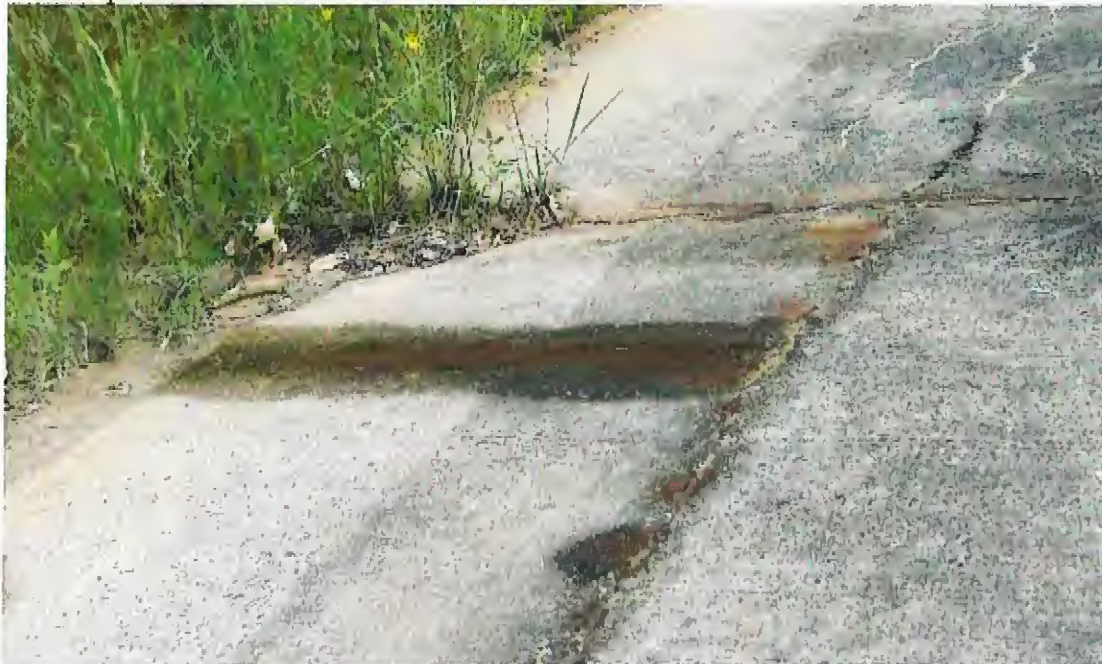
Photo #12 – View of dam's downstream slope near the right end of dam looking southeast. Some seepage appeared to be occurring at this crack in the concrete slab. Areas of seepage in the slab were also noted in the previous inspection.

- e) Monitor areas of seepage along the downstream concrete slabs and at the low-flow outlet. A log of seepage location and flow rates along with the lake level and date should be recorded and maintained.

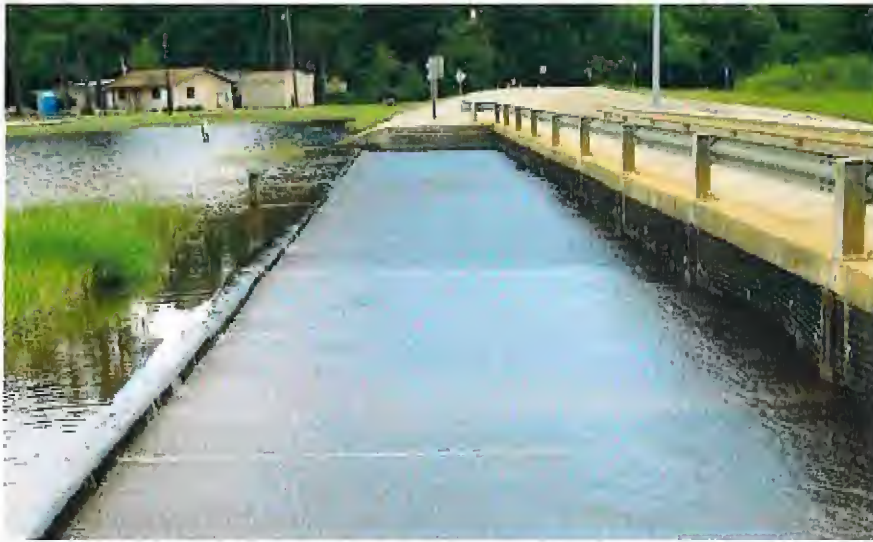
Photo #13 – View of the dam's service spillway looking north. Note the spillway was engaged approximately 2-inches during the inspection.

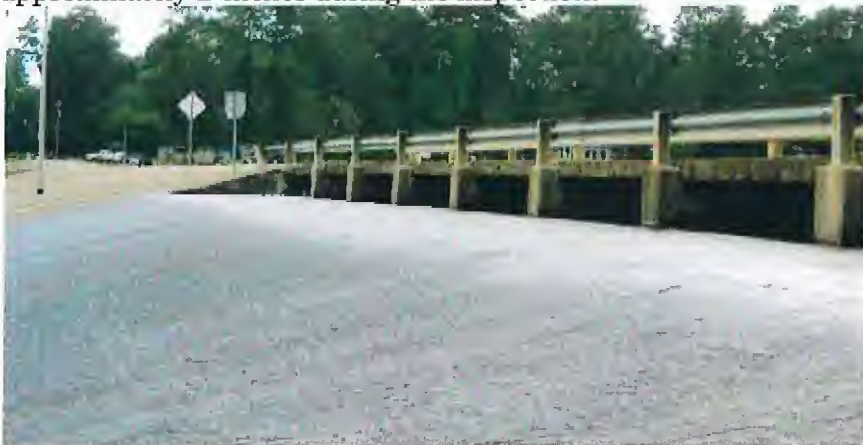
Photo #14 – View of the dam's service spillway looking southwest.

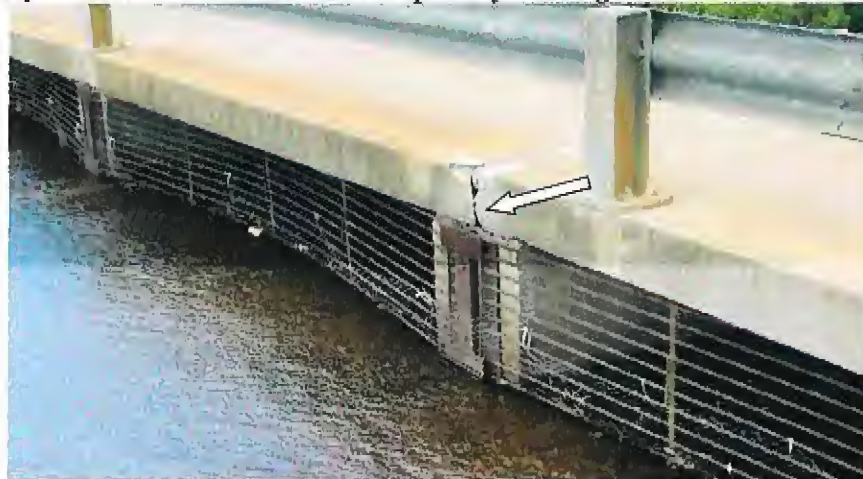
- The spillway is located at the left end of the embankment and consists of a 160-ft wide weir wall, debris grates, bridge and concrete downslope and stilling basin. The overall structure and components were found in fair condition (See Photos 13-19).
- Some cracking and spalling was evident around the concrete bridge and slopes next to the spillway/bridge (this appeared about the same as noted during the last inspection).
- Sediment buildup (which was partially cleared out during the grouting project) was evident at the right end of the stilling basin. This is the same location where boils and sediment buildup were noted in previous inspections.

Photo #15 – View of the dam's service spillway looking northeast. Note the wire grate at the spillway bridge. Also, some cracking (arrow) was observed at the bridge

- c) Heavy vegetation growing around the stilling basin area should be removed.
 - d) Repair spalling, and seal minor cracks throughout the concrete slabs, particularly around the bridge and service spillway area.

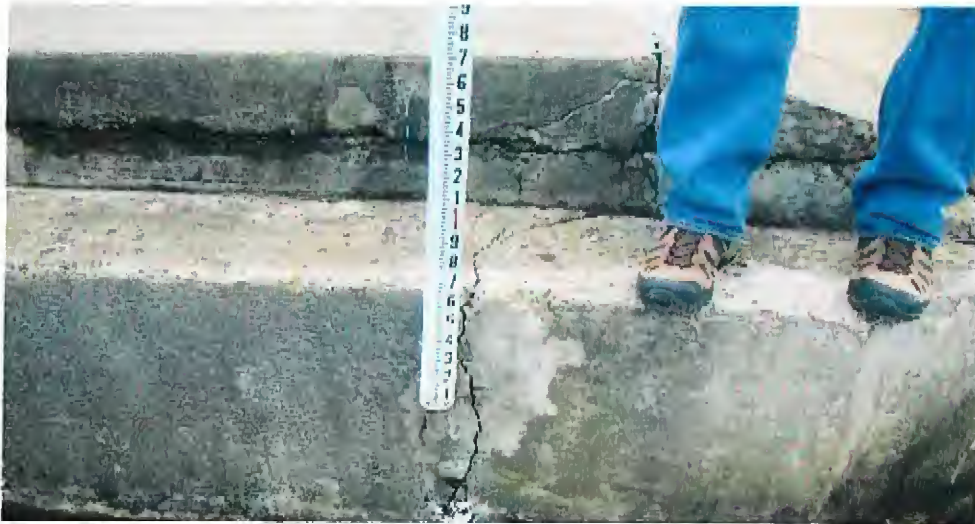
Photo #16 – View of cracking occurring in the concrete slab along the entrance to the spillway looking south.

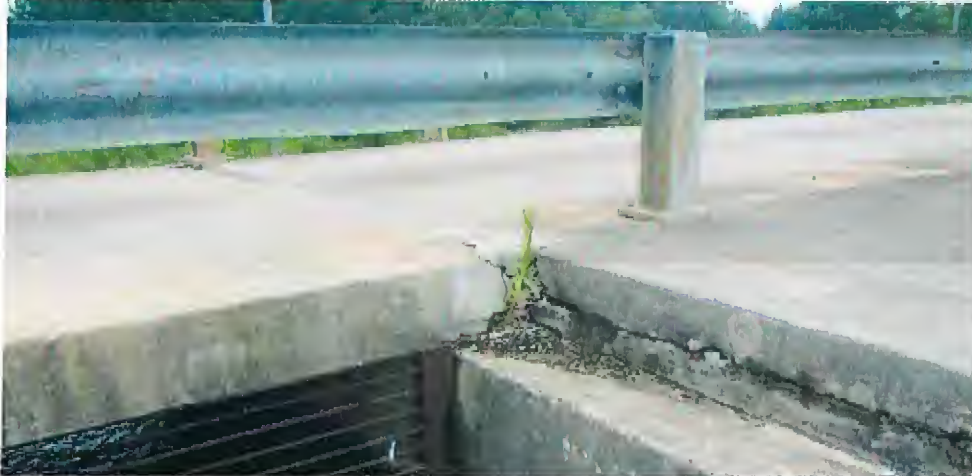
Photo #17 – View of cracking along the bridge at the spillway looking southeast.

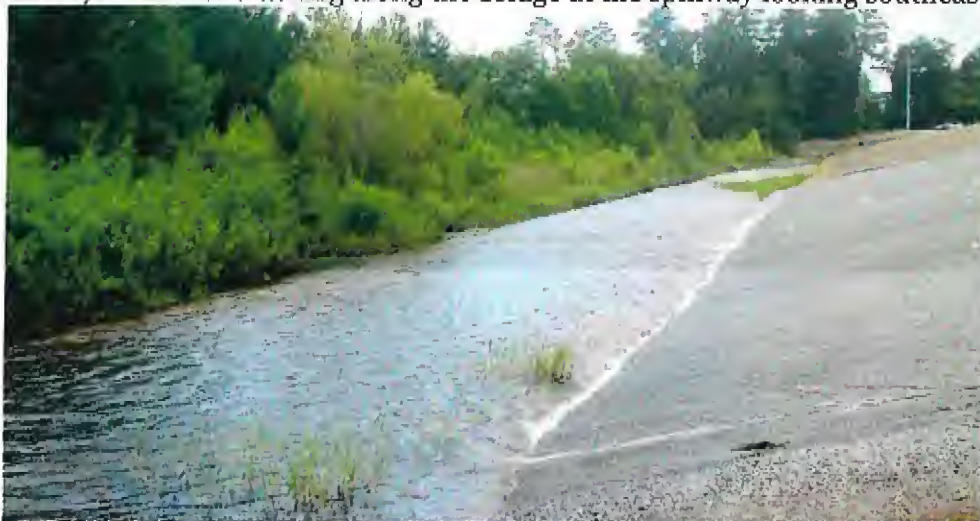
Photo #18 – View of the service spillway outlet and stilling basin looking southeast.

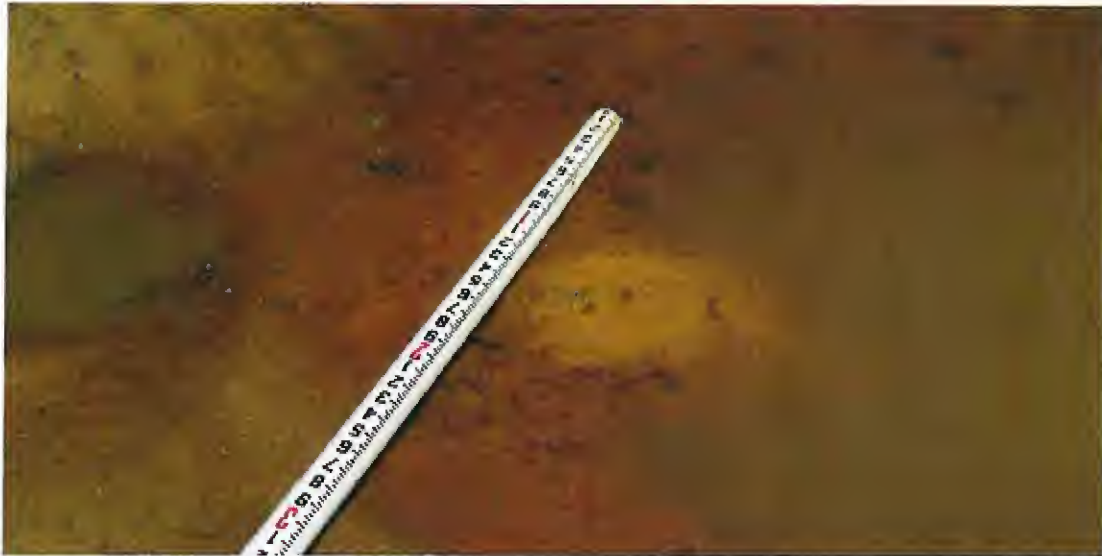
- At least one boil was identified in the same general location of the stilling basin as had been noted in past inspections. Mr. Harrison stated that there were now less boils than before the grouting project was completed.
- Heavy unwanted vegetation was noted to be growing around the stilling basin area.

Due to the potential piping condition occurring at the toe of the downstream slope of the dam, a significant storm event could raise the water level and head

pressure to accelerate any piping and cause a washout of the embankment material to such a degree that the concrete slabs could separate or fail and allow an uncontrolled loss of the reservoir.

Photo #19 – View of bubbling occurring at a boil located in sediment at the stilling basin just downstream of the concrete slope. Boils, which were noted during the last inspection, were also observed during this inspection. However, there did not appear to be as many or as large as noted in the previous inspection.

- The persistent problem with sand boils and sediment accumulation requires a licensed Texas Professional Engineer with dam experience to diagnose the problem and develop a long-term solution. The development of any plans requires submission and approval through Dam Safety prior to commencement of any construction improvements.

- b) Remove silt from the stilling basin area and monitor the inflow of new silt and quantity and condition of boils as they re-appear. Locations of the boils should be recorded with dates and quantity of sediment removal.

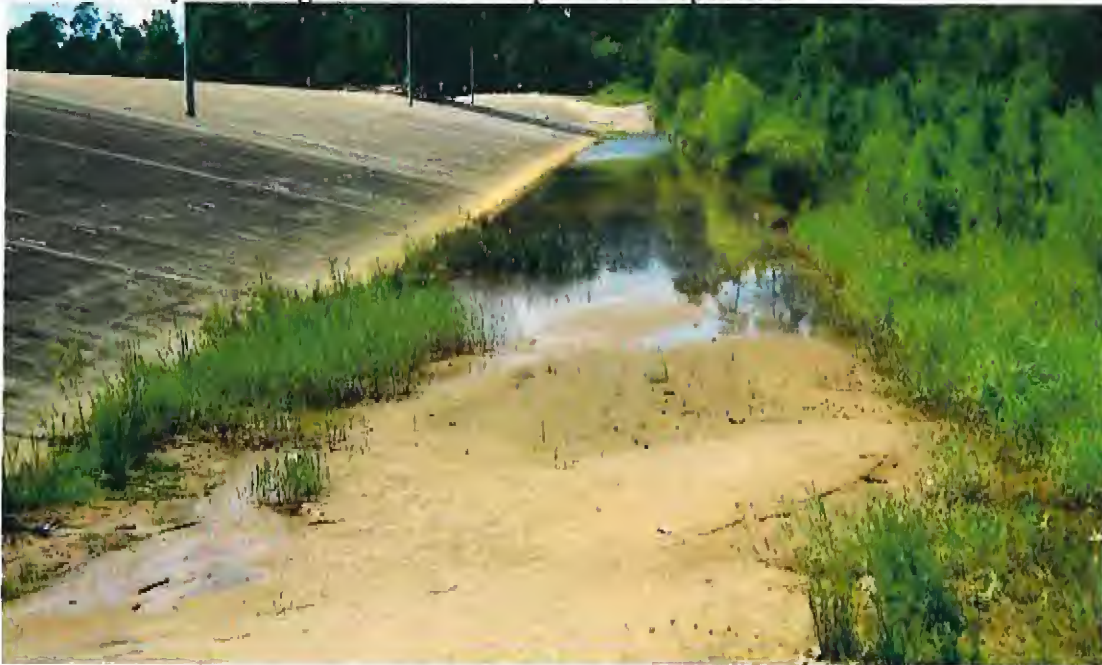
Photo #20 – View of sediment buildup and grass in the stilling basin area looking north.

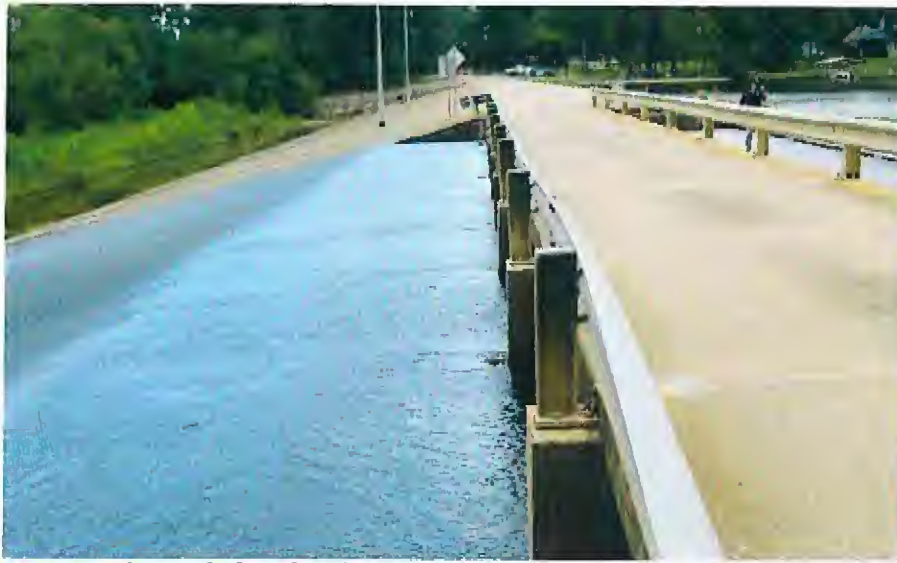
- The concrete capped portion of the embankment is capable of handling flows over the crest and roadway and therefore functions as an emergency spillway at up to 900-ft long. The overall structure was found in fair condition (See Photos 20 and 21).
- The spillway portion of the roadway is estimated to be about 3 feet below the abutments (not protected with concrete) on each end.

Photo #21 – View of the dam's concrete embankment which functions as the emergency spillway during an extreme storm event.

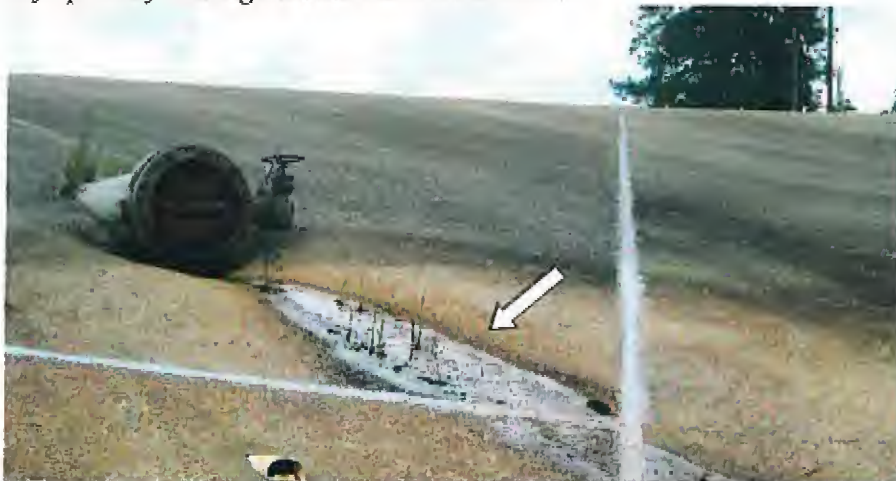
- The low-flow inlet/outlet is located on the left end of the dam (marked by a warning sign) and consists of 24-in. steel pipe and valve at the downstream end. Mr. Harrison stated that the pipe and valve is used regularly (See Photos 22 and 23).
- Evidence of potential seepage at the low-flow outlet was noted during this inspection. This appeared to be similar to what was noted in the prior inspection. Overall the outlet appeared to be in working condition.

Photo #22 – View of the dam's low-flow outlet (24-inch outlet and valve) at the north end of the embankment looking northwest. Note some evidence of seepage below the outlet as also noted in previous inspection.

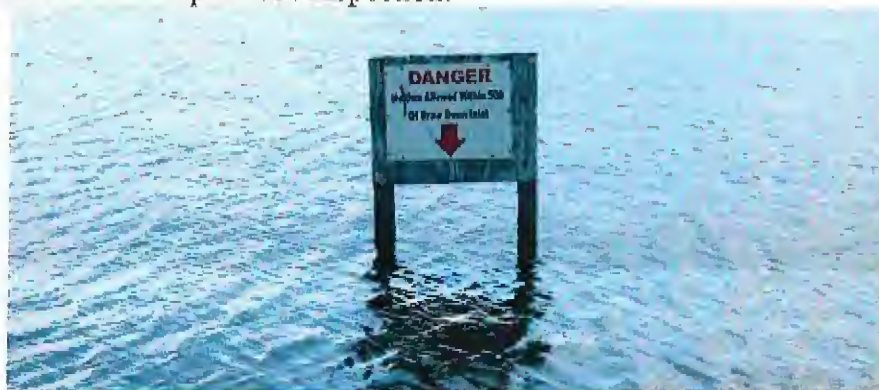
Photo #23 – View of warning sign where the low flow inlet is located just next to the left side of the embankment looking west.
